Comparison of Fracture Resistance of Amalgam and Composite in Abrasioned Teeth

Different materials and techniques are used in dental wear restoration with the objective of increasing teeth resistance, and providing an aesthetic appearance. The aim of this study was to compare the fracture resistance of amalgam and posterior composite in abrasioned premolar and molar teeth. In this study, 60 carries and restoration-free human permanent mandibular premolar and molar teeth, freshly extracted because of orthodontic, periodontal and surgery reasons, were used. Cusps of teeth were removed with a horizontally cut, and were randomly divided into four groups of 15 teeth each. Groups 1 and 2 received class II restorations with posterior composite and amalgam, respectively in 15 premolar teeth. Groups 3 and 4 had class II restorations with posterior composite and amalgam, respectively in 15 molar teeth. After finishing and polishing, all samples were subjected to 1.000 times thermocycling with a dwell time of 30 s at 5 ± 2 °C, and 55 ± 2 °C. Then, teeth were mounted in acrylic resin to a depth of 2 mm apical to the cemento-enamel junction, and force was applied to all samples in a universal

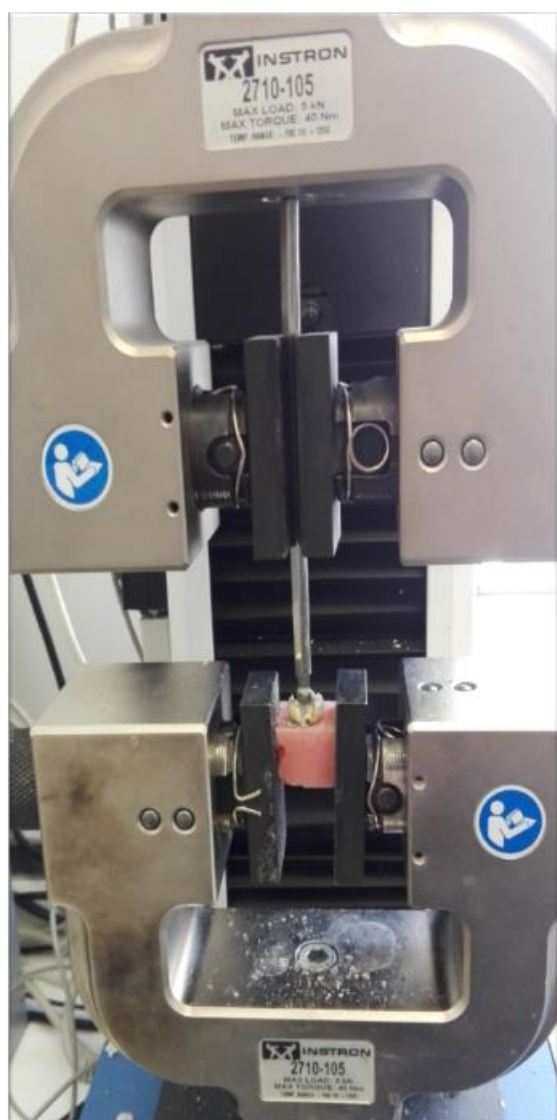
Figure 1. The analysis procedure for the samples using the universal test machine (TSTM 02500; Elista Ltd. Sti., Turkey). Force was applied at 1 mm/min until fracture.

After the finishing and varnishing procedures, all samples underwent 1000 thermal cycles (30 s waiting time) in water baths at temperatures between $5^{\circ} \pm 2^{\circ} \text{C}$, and $55^{\circ} \pm 2^{\circ} \text{C}$. Then, the teeth were embedded in acrylic blocks up to 2 mm below the enamel-cement border. Using a universal test machine (TSTM 02500; Elista Ltd. Sti., Turkey), force was applied at 1 mm/min until fracture (Figure 1). The fracture points
